Ormiston Academies Trust
Cowes Enterprise College
Delivering Project Closure

I Introduction

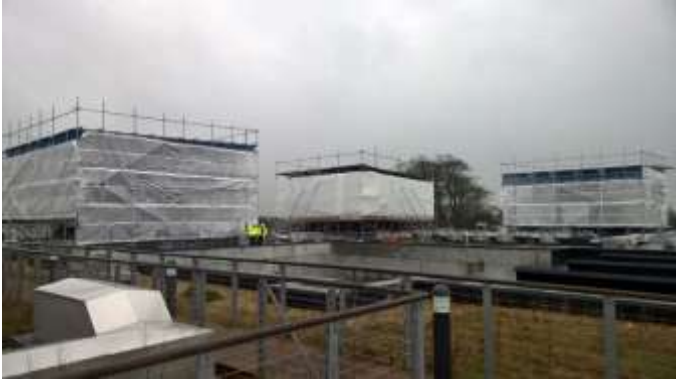
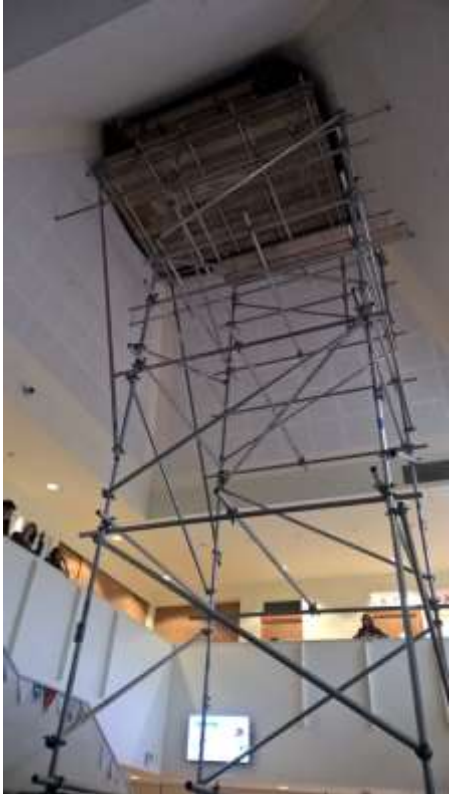
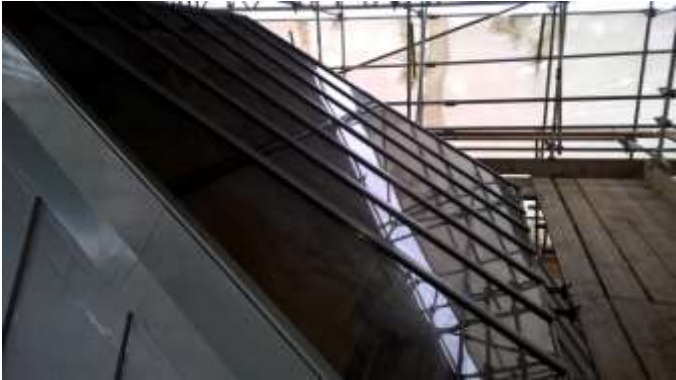
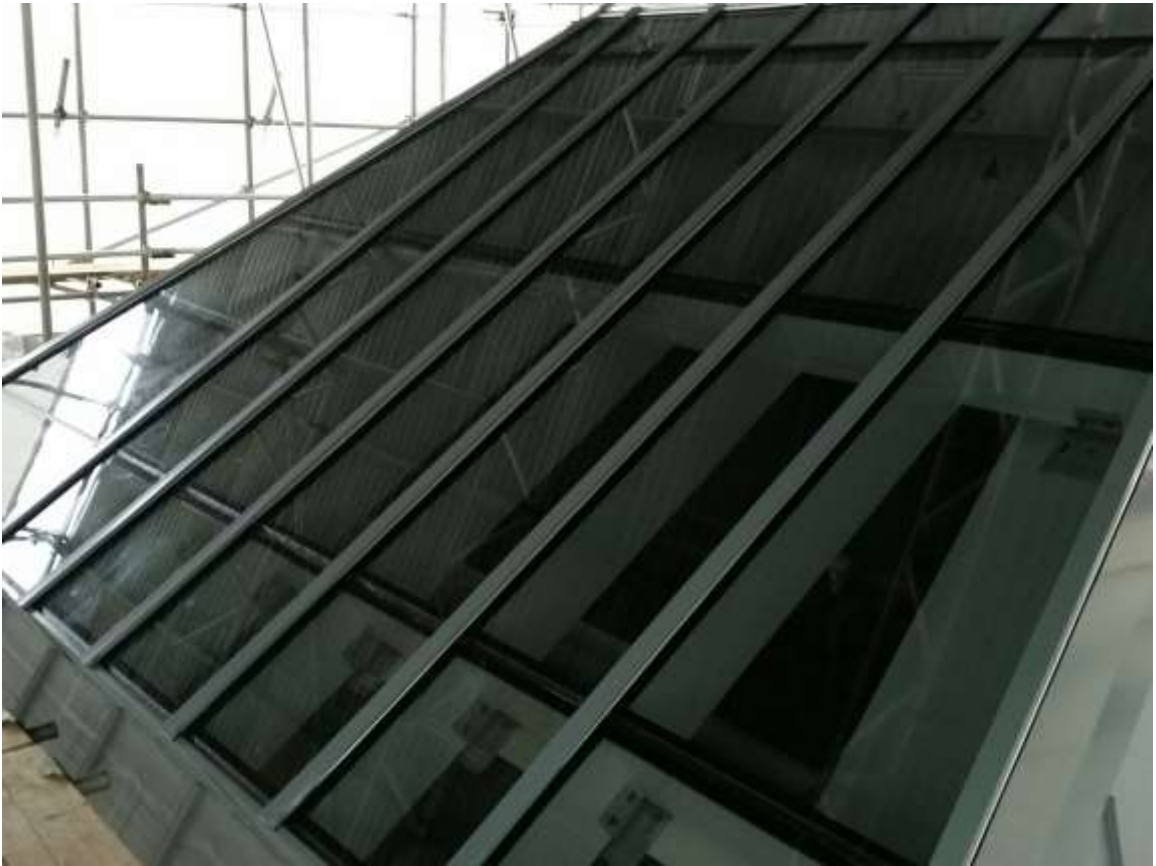
7 PHOTO UPDATE | ROOFING PHOTOS

A key issue with the roof construction centred around the 10 snoods over the light wells which are a distinct architectural feature of the building. Through invasive surveys it was found that the snoods had not been constructed correctly. The insulated metal deck panels forming the sides and main structure of the snoods had been secured with an inappropriate type and number of fixings. The junctions between the panles at intersections were very poorly excuted resulting in significant cold bridging and condensation issues.

The glazing system used was wholly inappropriate and presented a health and safety risk with the possibility of glass units falling through into the academy areas below.

A key requirement was to achieve a 20 year product warranty for the roofing works. This was achieved by utilising a combination of Bauder roofing and Comar glazing products for the snood refurbishment works. The Bauder membrane for the snoods could be sealed to the existing Bauder flat roof covering, thus creating an entire envelope for the roof and snoods via a single supplier.

John Nicholson Roofing, a local Bauder approved specialist, were contracted to complete the works. To identify the key issues and establish a procedural method of working a single snood was stripped and reinstated initially. A defined construction process was then established which was rolled out over the remaining 9 snoods. A 20 year warranty for both the glazing and roof covering was issued on completion

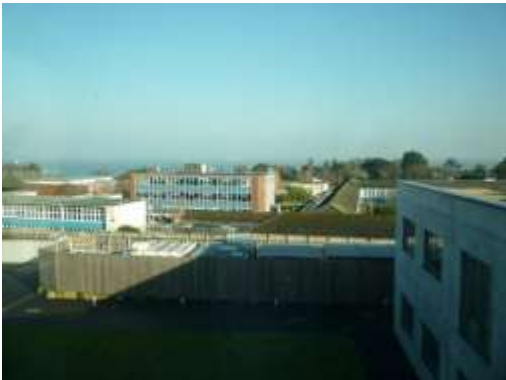
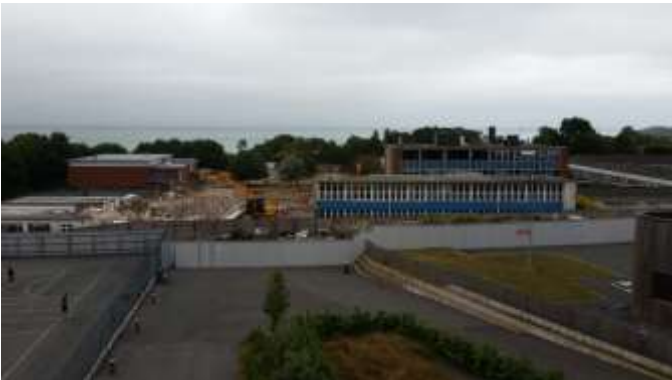
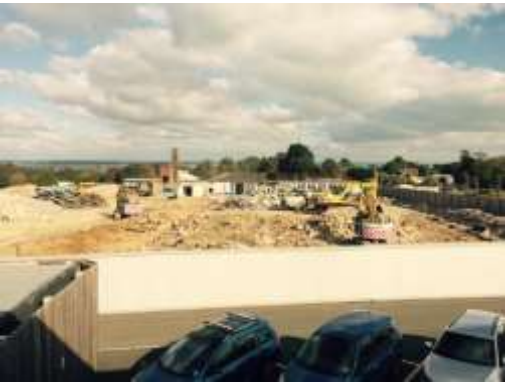
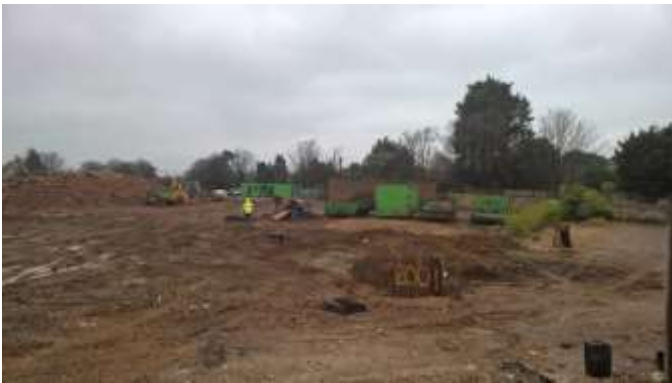
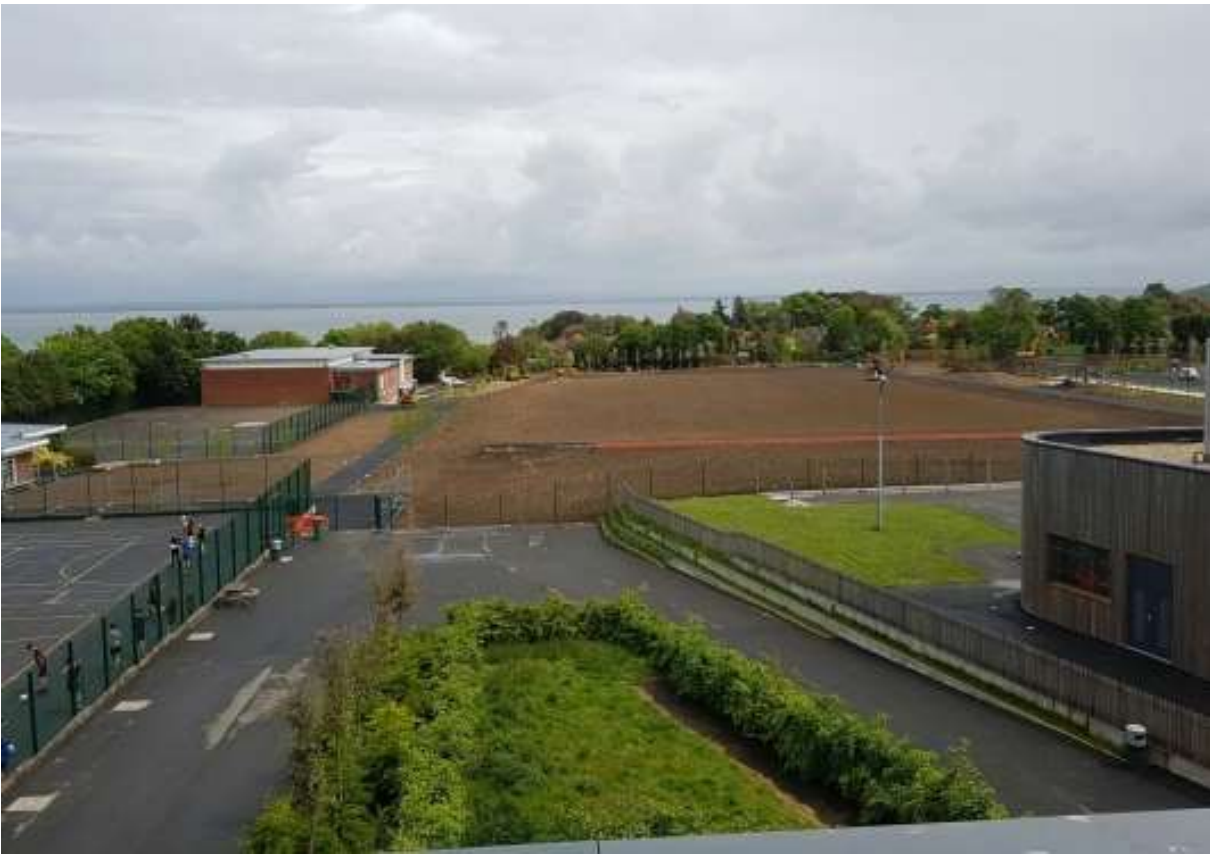
8 PHOTO UPDATE | DEMOLITION AND LANDSCAPING

The business case identified that the original school buildings remained in place following the construction of the new academy. Once they had been demolished the key task would be to create a fully landscaped solution to the area previously occupied by the Former Cowes High School and bring the 1990's built Sports Centre Back into use.

JPC's Demolition and landscaping team started the works to demolish the existing redundant school buildings in July 2015.

The landscaping works to reinstate the areas left exposed after the demolition was completed in Spring 2016 but only started to be used by the academy in late 2016.
